PETER HUGHES
PROPERTY INSPECTIONS

Pre Sale Inspection Report
To AS4349.0-2007 Inspection of Buildings General Requirements

Property Address: 44 Jaeger Av Gunnedah NSW 2380

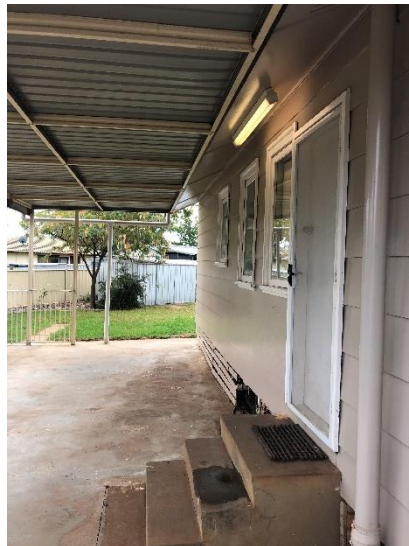
Patios: Defects/Safety Hazards found were moisture dripping onto back step. This appears to be caused by a blocked and leaking gutter. Consult with a licensed plumber for repair.

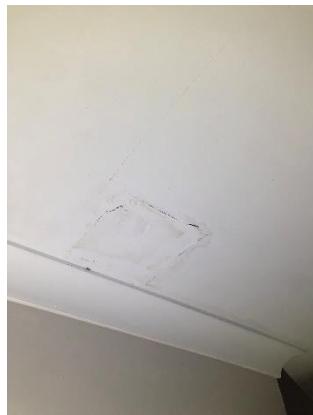
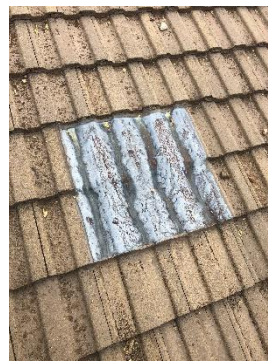
Lounge Room: Defects/Safety Hazards found were moisture stain can be seen on the ceiling. No moisture detected at the time of the inspection. Lead flashing patch on roofing indicating damage repair.

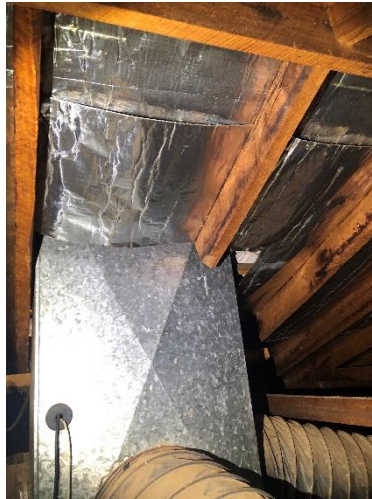
Roof Framing: Defects/Safety Hazards found were cut rafter above air conditioning unit. This may weaken structure. Consult with a licensed builder for recommendations.

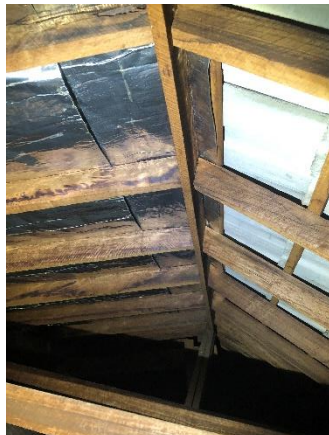
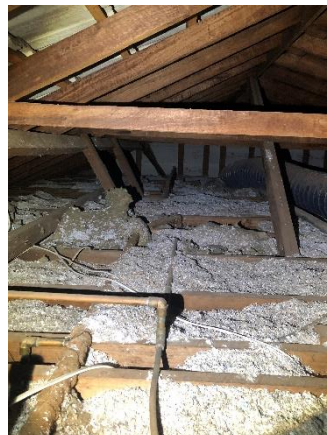
Sarking: Defective as only partly installed.

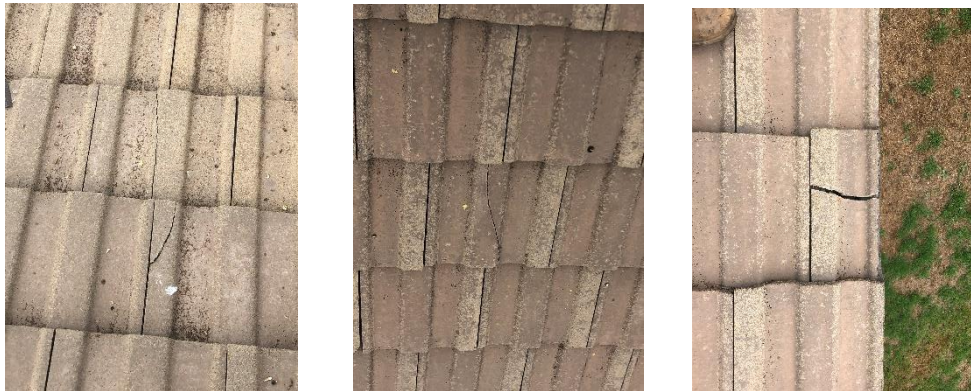
Roof Flashings: Defects/Safety Hazards found were cracked tiles creating possible waterproofing defects. Consult with a licensed roof plumber for repair.
